# Cox Bay Stream Monitoring Report

## March 2009

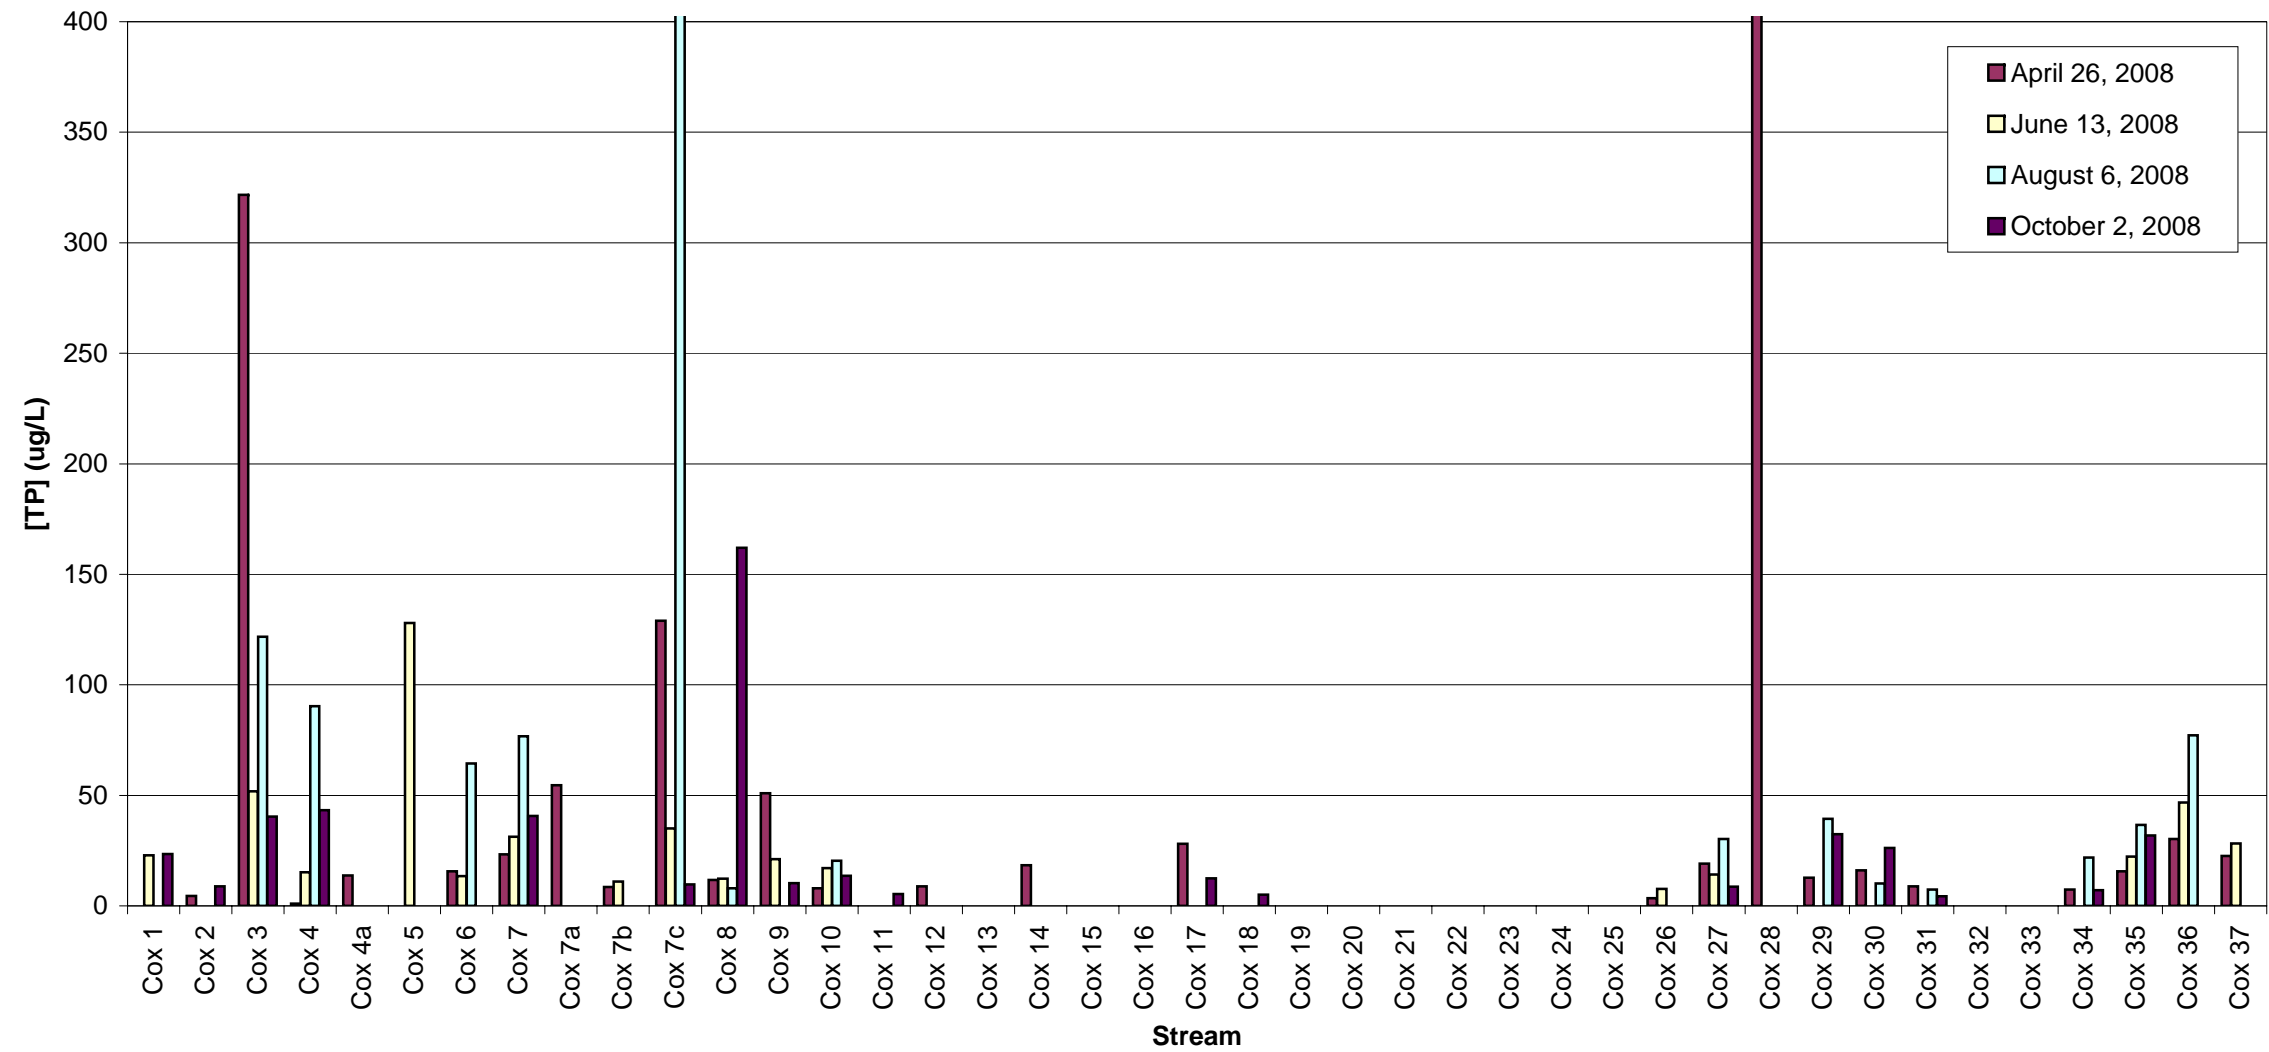
[TP] in Cox Bay Streams, 2008

Of the remaining 28 streams, nine of them had phosphorus concentrations that exceeded 50µg/L on at least one occasion. While 50µg/L is not objectively determined to be an acceptable threshold of phosphorus concentration in these streams, it is a useful benchmark (or 'functional' threshold) by which to enumerate the streams that have a higher load impact than others leading into Cox Bay.

Stream	Discussion
#3	Three out of four <sup>2</sup> measurements exceeded 50µg/L. This stream runs from the lake across residential property through buried piping (extremely close to a septic bed) and drains a larger area that includes tennis courts and open grassy areas near the Lake Joseph Club. While it is identified as an intermittent stream, it was flowing during all four sampling occasions, so may be a significant source of TP loading.
#4	One out of four (August) measurements exceeded 50µg/L for this stream which drains road ditches near the Lake Joseph Club. This single result may have been caused by an isolated event and should be confirmed by further monitoring. This intermittent stream was flowing during all four sampling occasions.

#5	This stream was only sampled once (June) but significantly exceeded the benchmark of 50µg/L. This suggests that the stream may be a significant source of TP loading when it flows. This should be confirmed by re-sampling.

#7	One out of four (August) measurements exceeded 50µg/L for this stream which drains part of the Lake Joseph Club golf course before crossing residential property. It is identified as a permanent stream, and therefore could represent a significant TP loading. The fall 2007 measurement was also well above 50µg/L.

#7A	This stream was only sampled once (April) but exceeded the benchmark of 50µg/L. This suggests that the stream, which drains parts of the Lake Joseph Club golf course, may be a significant source of TP loading when it flows during the spring run-off period. This should be confirmed by re-sampling.

#7C	Two out of four (April and August) measurements exceeded 50µg/L for this stream which drains a residential property. While it is identified as an intermittent stream, it was flowing during all four sampling occasions, so may be a significant source of TP loading.

#8	One out of four (October) measurements exceeded 50µg/L for this stream which drains road ditches near the Lake Joseph Club. While the October 2 measurement significantly exceeded the benchmark, other measurements were quite low, so this result may have been caused by an isolated event and should be confirmed by further monitoring. This intermittent stream was flowing during all four sampling occasions.

#28	This stream was only sampled once (June) but significantly exceeded the benchmark of 50µg/L. This suggests that the stream may be a significant source of TP loading when it flows. This should be confirmed by re-sampling. The stream is near Henshaw Creek, and drains an area on residential property.

#36	One out of three (August) measurements exceeded 50µg/L for this stream which drains a wetland upstream from Orgill's Bay. Since this area drains a wetland, high TP concentrations are likely natural and to be expected. For this reason, it is probably not necessary to continue monitoring in this location.

A review of the monitoring results suggests that three of the streams leading into Cox Bay should be investigated for sources of TP loading which could be mitigated. These streams are #3, #7 and #7C.

The review further suggests that a five more streams may have a significant impact; future monitoring should be used to confirm this conclusion while mitigative strategies focus on the above mentioned streams. These streams are #4, #5, #7A, #8 and #28. Note that streams #5, #7A and #28 were each flowing during only one monitoring occasion, so it is important to sample these streams during the heaviest period of spring run-off or after a very heavy rainfall.

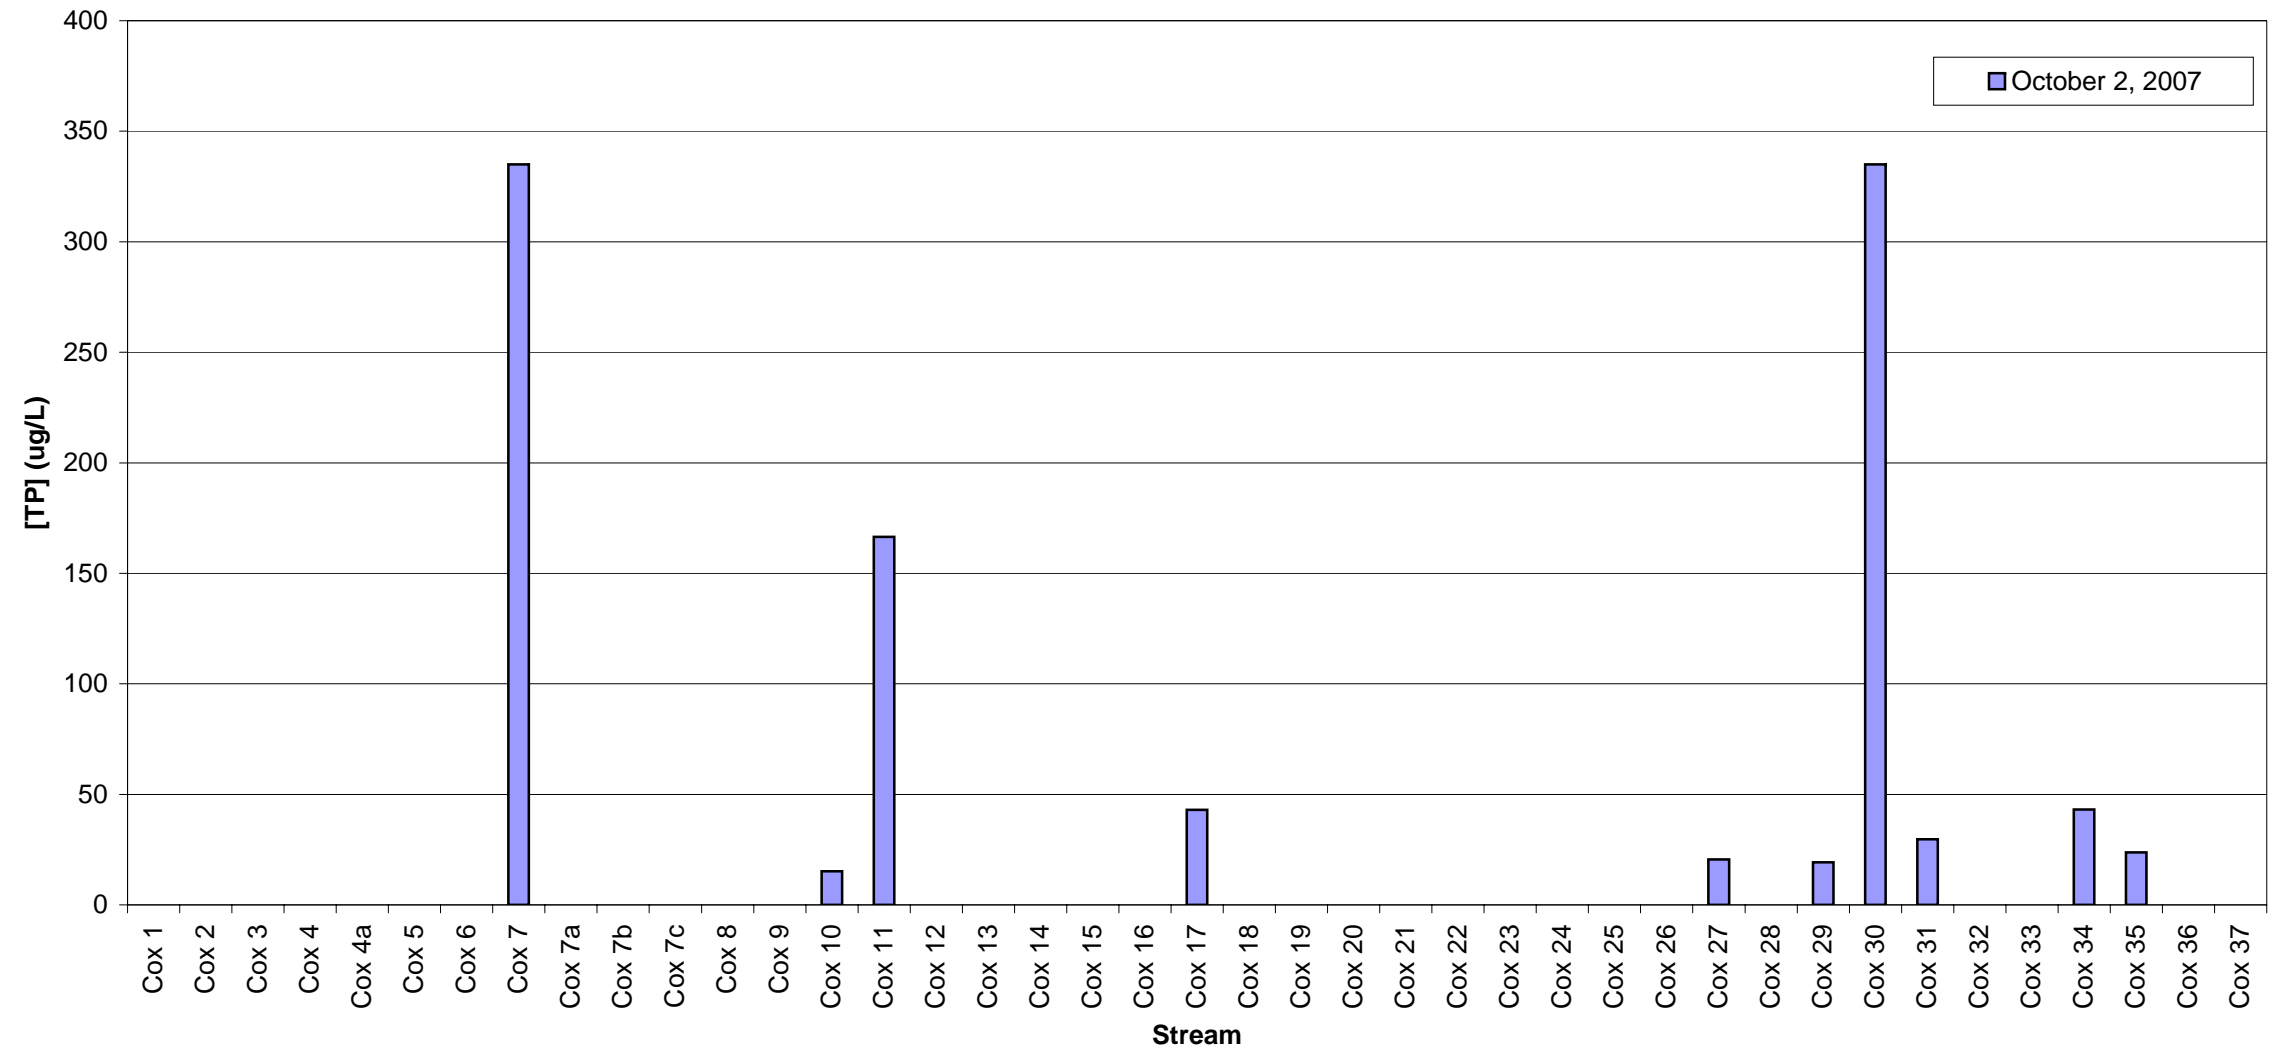
[TP] in Cox Bay Streams, 2007

Results are shown in the graph in Appendix B. Appendix C contains results collected late in the fall of 2007. While it is prudent to focus on the results collected in 2008, the results from 2007 can be used to confirm the conclusions drawn in 2008.
