WATER QUALITY INITIATIVE Water Quality Report 2012

January 2013 RS# 2009-06

SUBJECT: Muskoka Lakes Association Water Quality Initiative – 2012 Water Quality

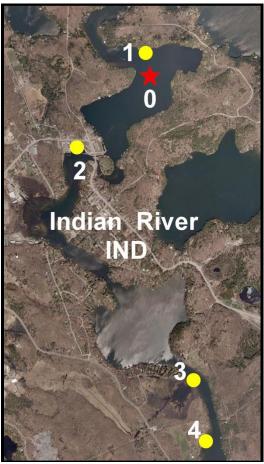
Photograph 1. Overview of the Indian River and the MLA sampling sites.

The Indian River is located between Lake Rosseau and Lake Muskoka with the town of Port Carling being located in the central portion of the river. The drainage area of the Indian River is approximately 3.0 km² in size and includes Mirror Lake (**Photograph 1**). In 1997, the northern portion of the Indian River contained approximately 1.5 km² of urbanized area with 118 developed lots within 300 m of the shoreline (Gartner Lee 2005). In contrast, the southern portion of the Indian River (south of Mirror Lake) contained no urbanized area and as of 1997, only 34 developed lots (Gartner Lee 2005).
